FHWA/IN/JHRP-94/13
Final Report

FATIGUE STRENGTH OF GIRDERS
WITH TAPERED COVER PLATES

Ahmed F. Hassan and
Mark D. Bowman

PURDUE UNIVERSITY

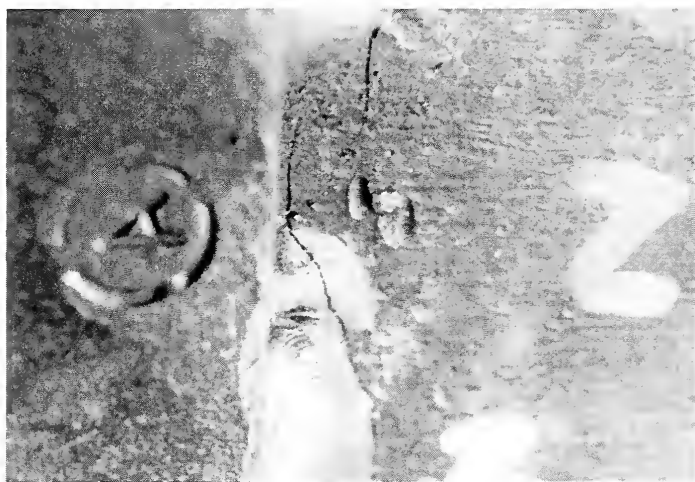
Fig. 6.10. Non-Coalesced Cracks - Specimen NR3 North End.
